## Automated Rapid Post-Disaster Assessment Using Uncrewed Aerial Vehicles

Nima Shirzad-Ghaleoudkhani<sup>1</sup>, Daniel Jozi<sup>1</sup>, Melissa Milena Trigueros Bedia<sup>1</sup>, Shaghayegh Abtahi<sup>1</sup>, Maziar Jamshidi<sup>1</sup>, and Mustafa Gül<sup>1</sup>

<sup>1</sup>Department of Civil and Environmental Engineering, University of Alberta, Edmonton, Canada.

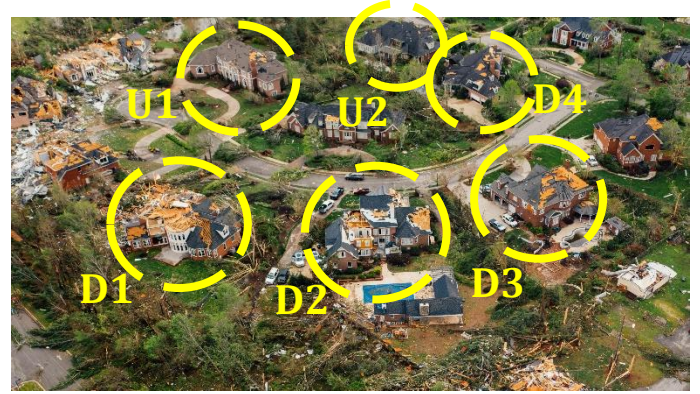
Tennessee, USA. Six residential houses were selected for evaluation, as shown in Fig. 1, and labelled with the letters D (damaged) and U (undamaged). The corresponding damage analysis results are summarized in Table 1. Findings show that when all extracted features are utilized, the method correctly distinguishes between damaged and undamaged houses. In contrast, relying solely on texture features (dissimilarity and homogeneity) or solely on edge features (angle distribution and entropy) leads to misclassification in some cases. This highlights the critical role of combining both texture and edge features to achieve reliable damage detection.

**Fig 1** An image showing post-hurricane damages in Chattanooga, Tennessee, US in April 2020.

**Table 1:** Damage assessment results for selected houses in Fig. 1.

True Category	Damaged				Undamaged	
Building Label	D1	D2	D3	D4	U1	U2
Probability of being damaged using texture features only (%)	100	99.9	99.7	82.8	55.5	51.6
Probability of being damaged using edge features only (%)	83.9	62.2	63.9	14.4	4.2	20.0
Probability of being damaged using all features combined (%)	100	100	99.9	59.8	9.0	32.9
